**“THEN YOU’LL HAVE A FINE HOUSE...”:
THE NEW FRAME HOUSE OF NORWEGIAN IMMIGRANTS
ANNA AND HANS GOULSON,
SWIFT COUNTY, MINNESOTA**

April 2011

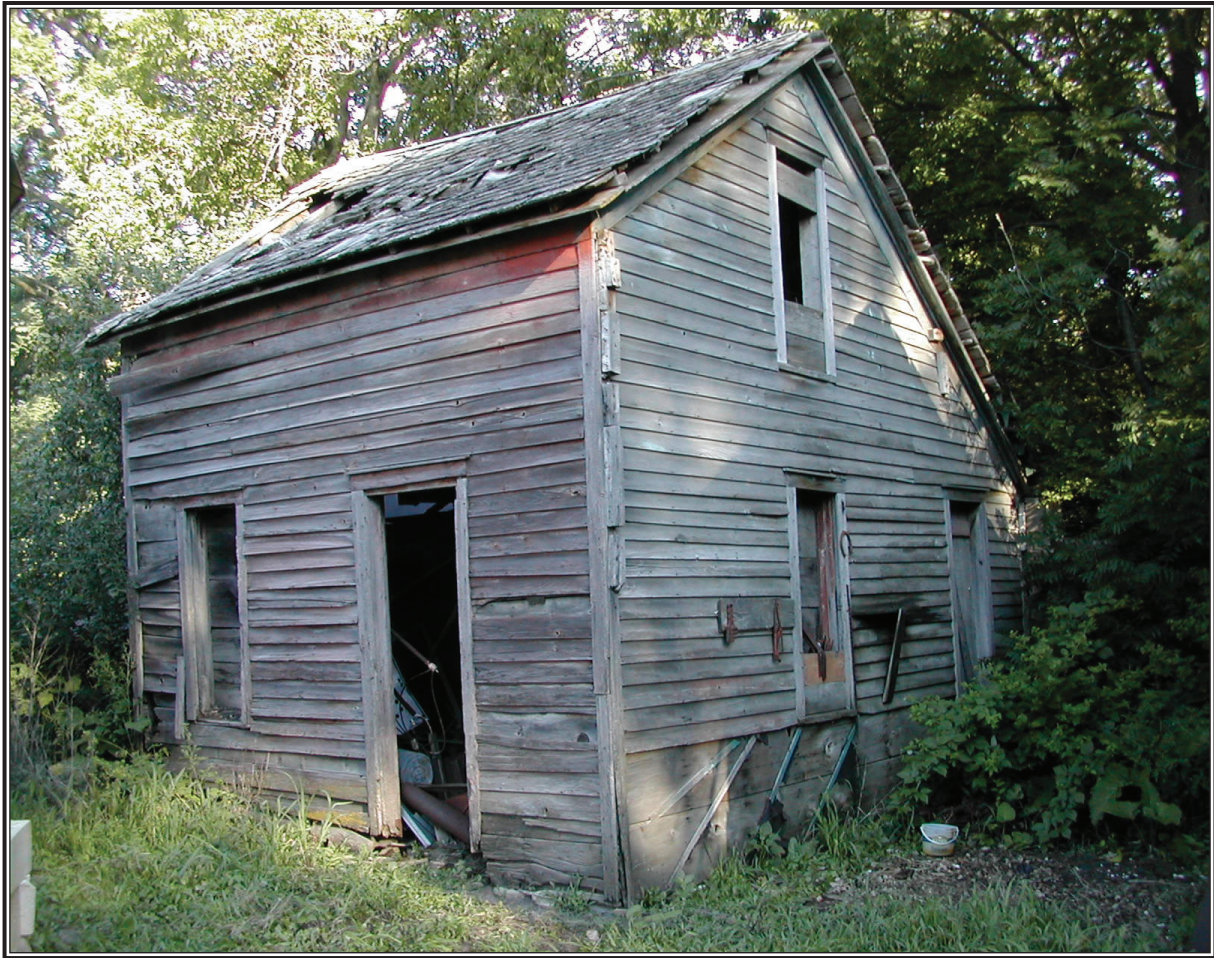
Figure 1.5. Prior to stabilization, the Goulson frame house was filled with discarded equipment and in precarious physical condition.

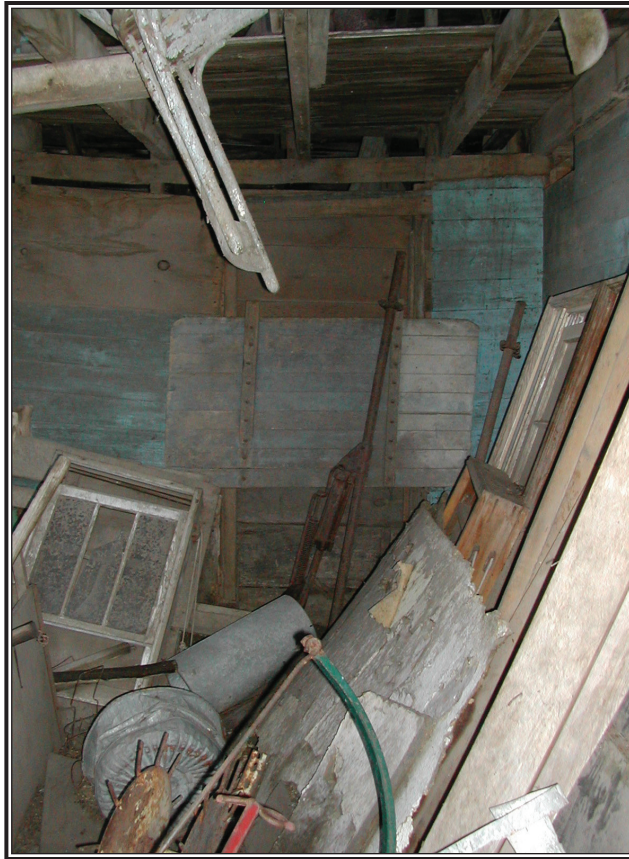
Figure 3.1. Condition of the interior of the frame house prior to documentation.

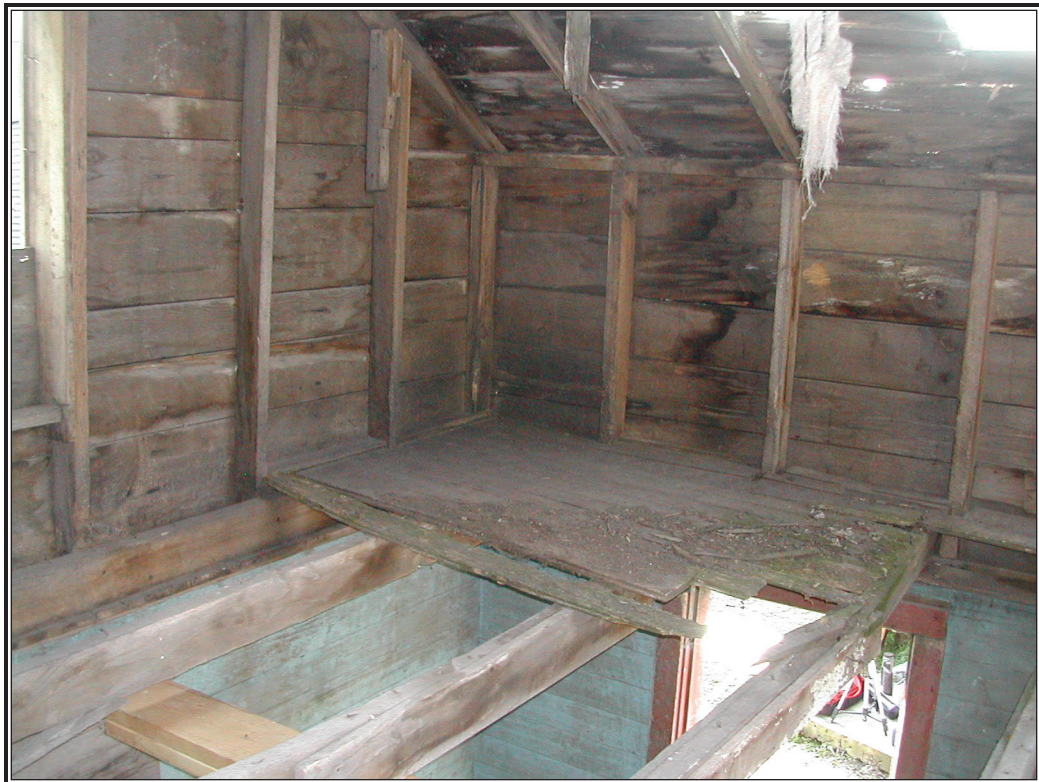
Figure 3.23. Current conditions of the loft in the Goulson frame house, where only wall studs and floor joists remain.

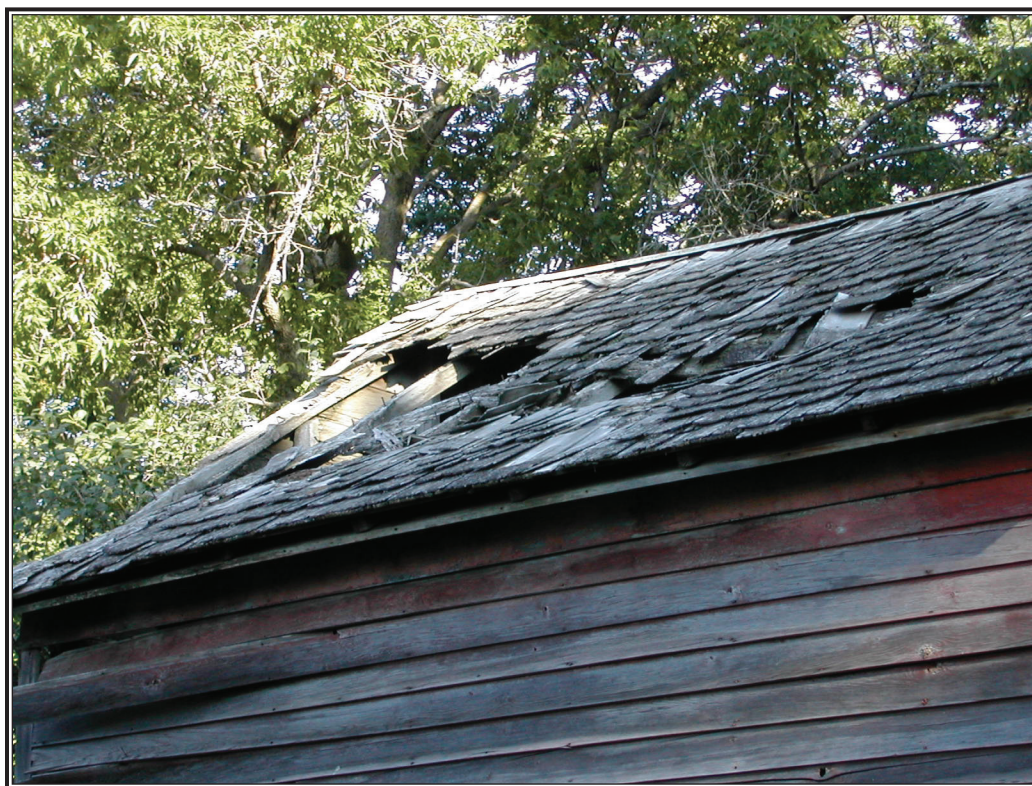
Figure 5.1. A hole in the western section of roof exposed the framing and interior to extensive water damage.

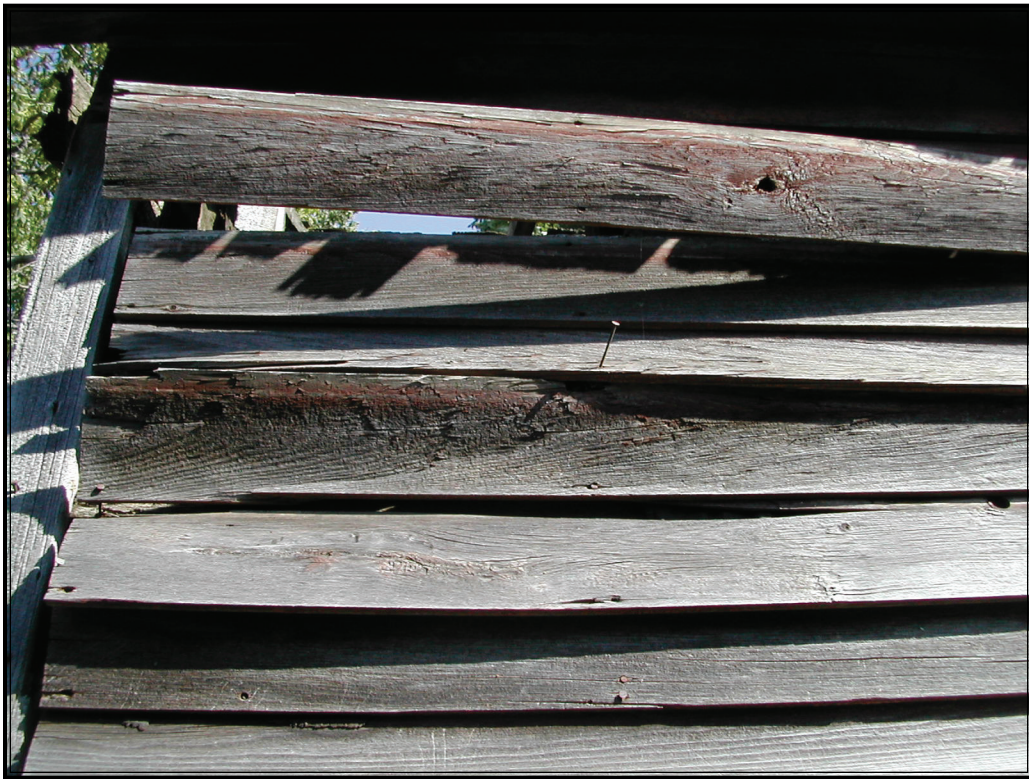
Figure 5.2. Loose and warping weatherboards on the principal (south) facade of the Goulson frame house.

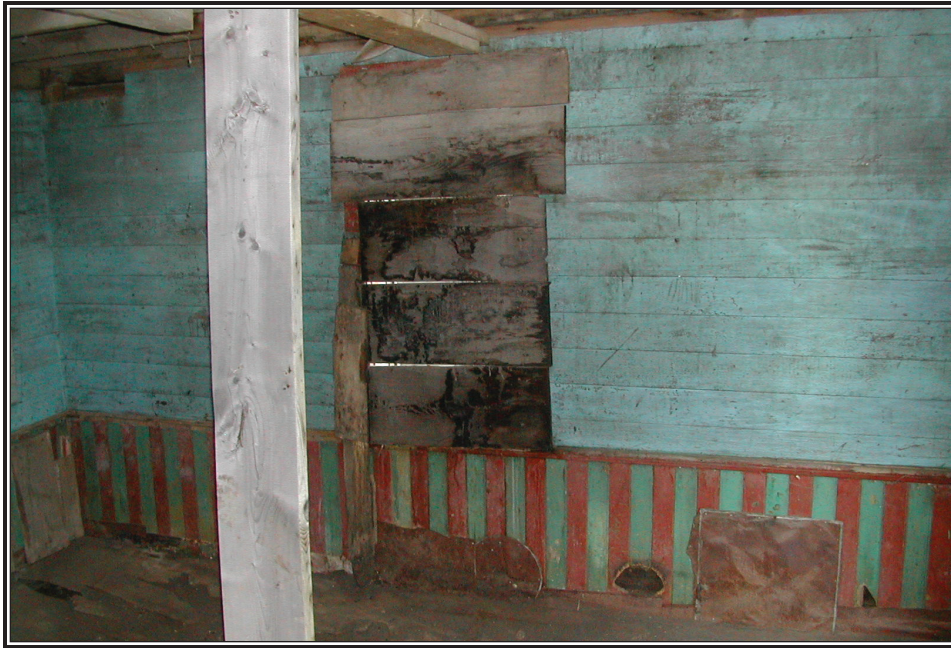
Figure 5.3. Openings in the building were boarded up from the inside and outside, including this window in the main room.

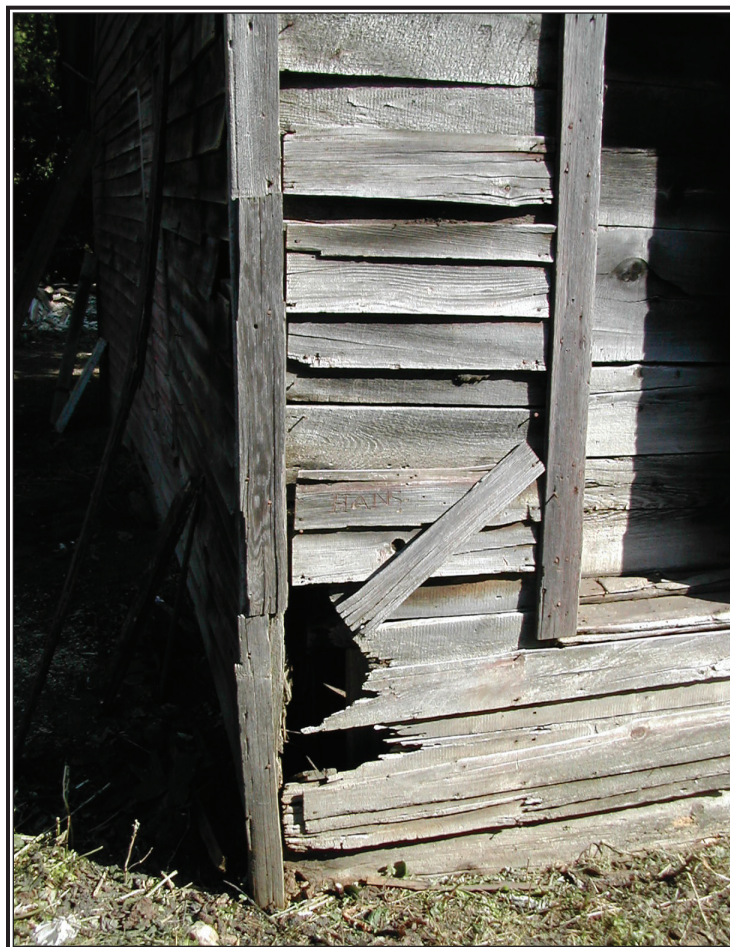
Figure 5.4. Loose and rotten weatherboards at the southwest corner of the Goulson frame house (note boarded window opening to right).

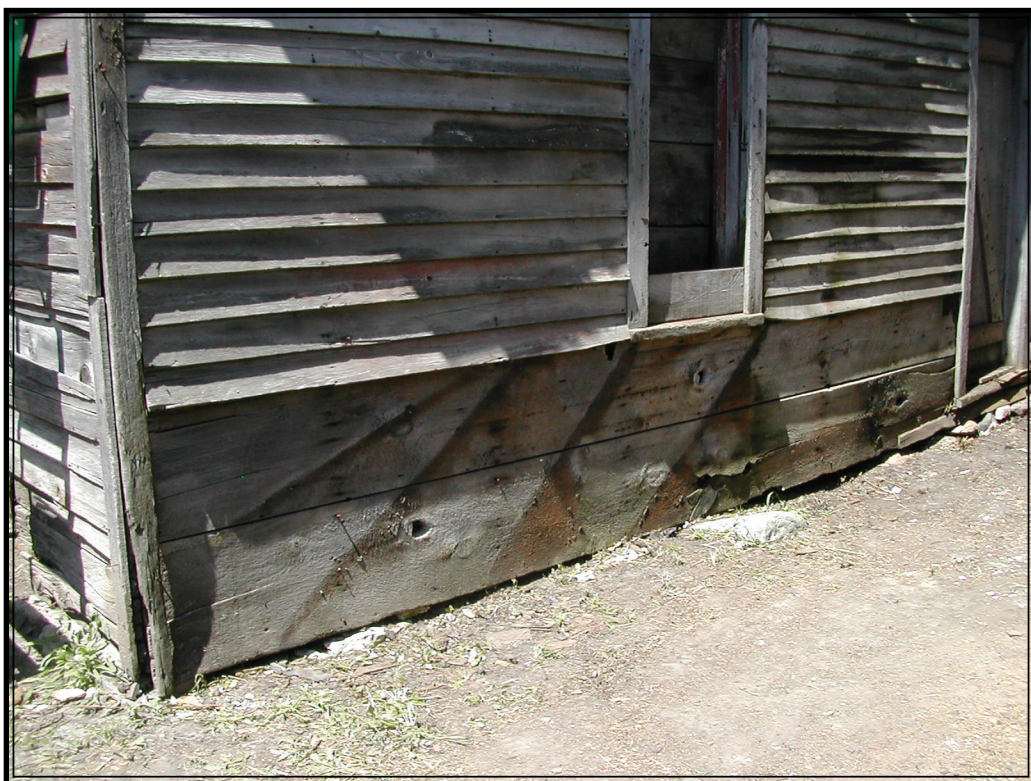
Figure 5.5. A large section of weatherboards is missing from the east facade, exposing the sheathing beneath.

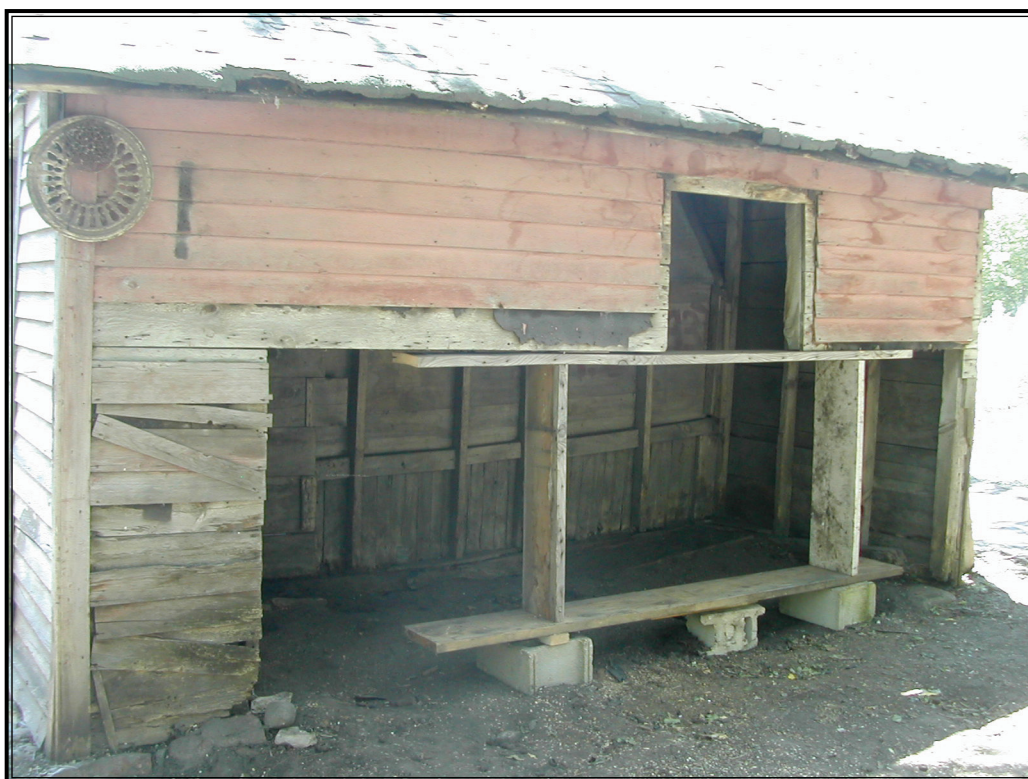
Figure 5.6. The north facade has extensive structural damage from when it was converted for equipment storage, and many of the weatherboards are loose or missing.

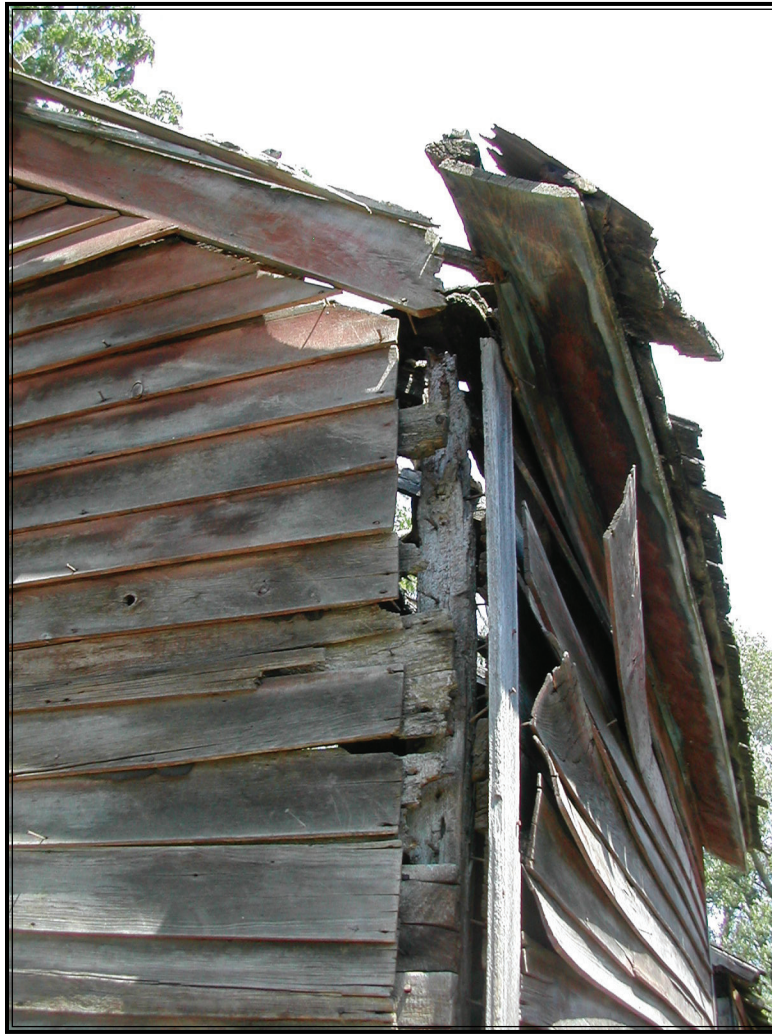
Figure 5.8. Due to water damage, the front (south) wall is pulling away from the west wall.

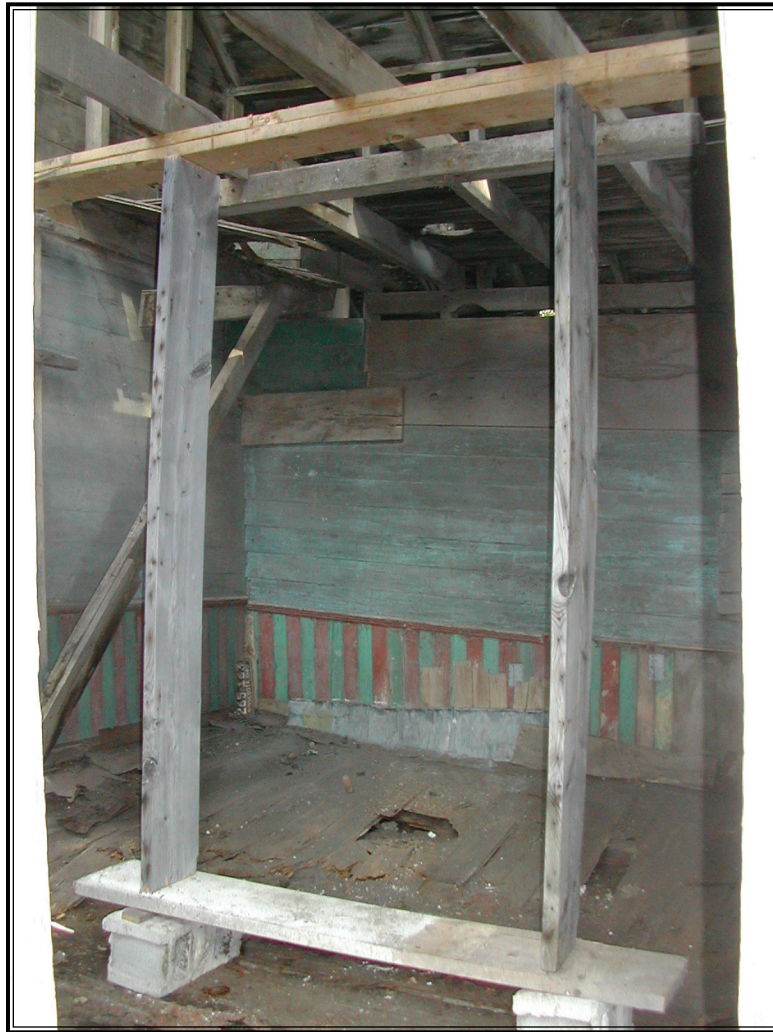
Figure 5.13. This bracing was added inside the Goulson frame house before its documentation to prevent the possible collapse of the first floor ceiling rafters, and allow access to the upper floor.

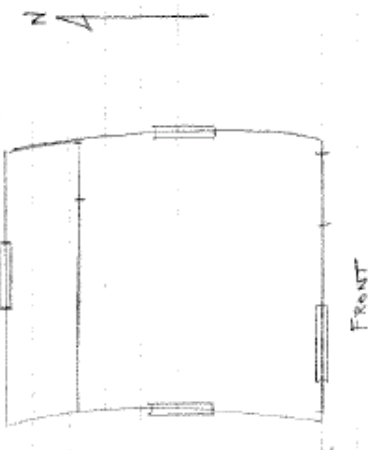
DRAWING EXAGGERATED TO SHOW BOW IN IN EAST & WEST WALLS.

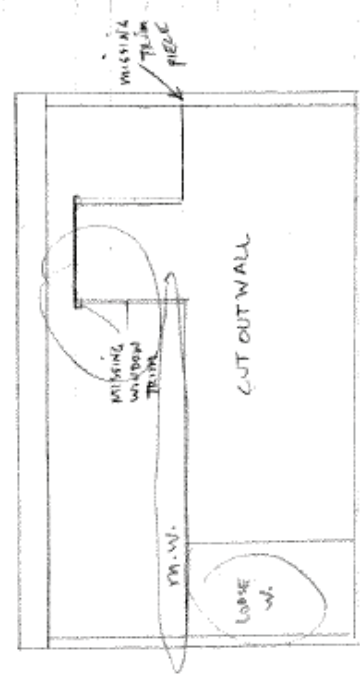
NORTH FACADE
(NOT TO SCALE)
M.W. = MISSING WEATHERBOARD
